# RAM Construction Services: Iconic Book Buildings Get a New Cover

PHOTOS SUPPLIED BY RAM CONSTRUCTION SERVICES

## The Construction “CliffsNotes” for the Book Buildings’ Restoration

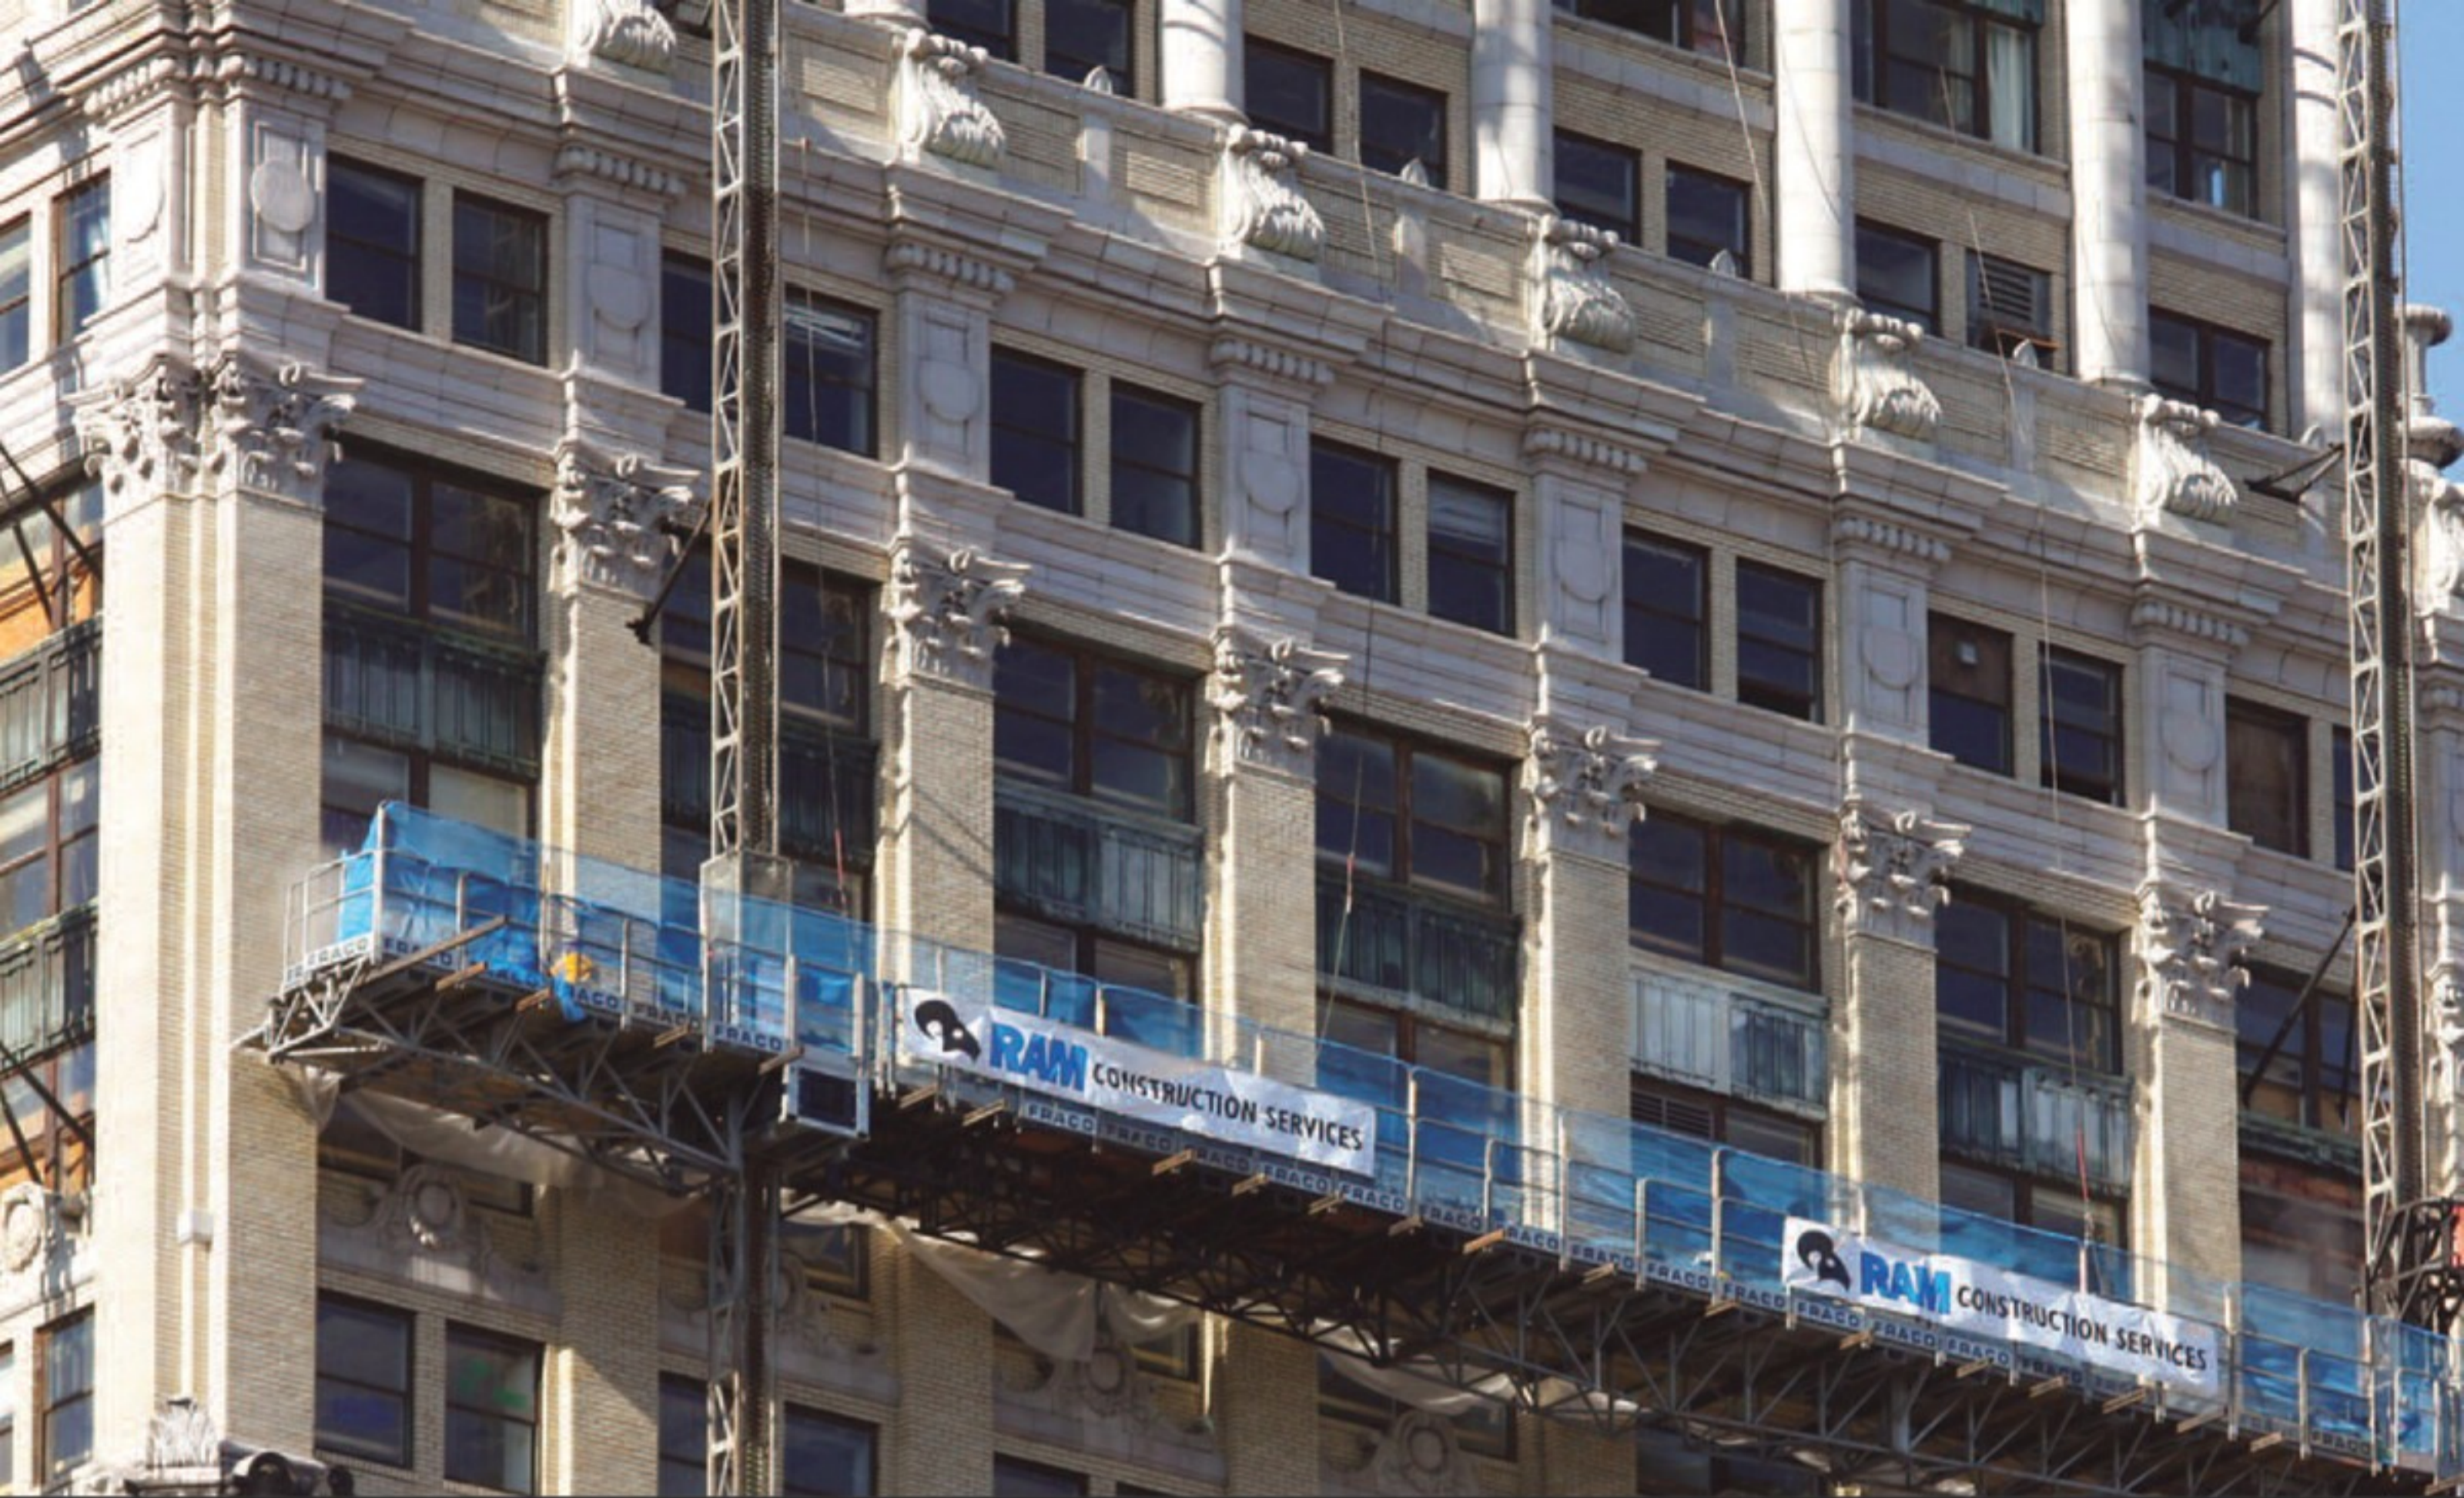
**Left/Middle:** Removed in 2016, the damaged terra-cotta sculptures had been architecturally supporting the cornice of the Book Building, circa 1917, for just under a hundred years. Each of the 13-foot-tall female sculptures, called caryatids, is now replicated in fiberglass.

In 2016, RAM Construction Services removed each 13-foot-tall caryatid in pieces and reassembled two of the sculptures in their entirety, one for the maidens supporting the cornice with their right arms and another for those supporting the cornice with their left arms. Glassline, Inc., Plymouth, fabricated molds for the replication of all 12 caryatids in

glass fiber reinforced polymer (GFRP), or simply fiberglass. Today, these muses of the building arts once again grace this Italian Renaissance structure designed by famed Detroit architect Louis Kamper.

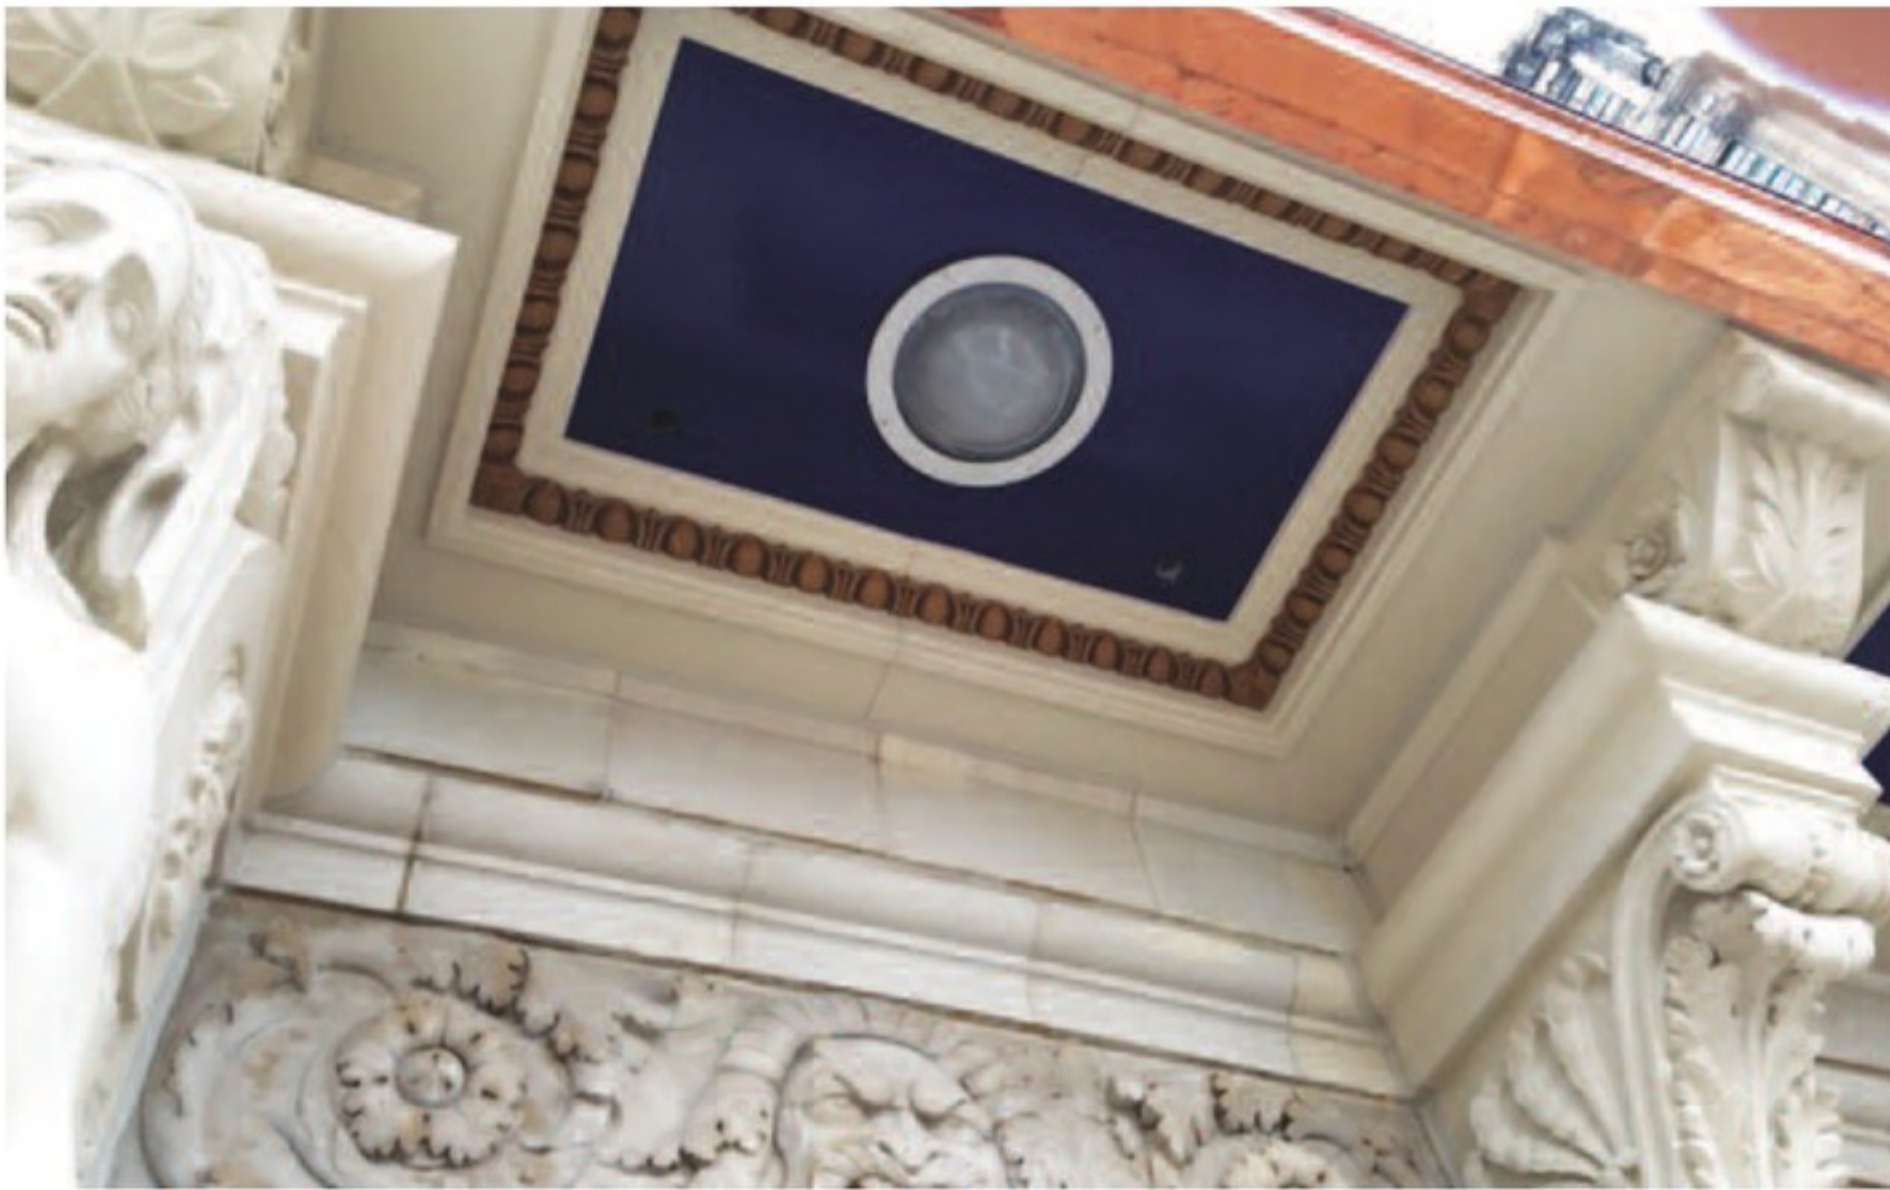
The entire east cornice of the Book Building was removed and replicated, including installing new support steel, replicating the original ornamentation in glass fiber reinforced polymer, and replacing the cornice's deteriorated copper sections with newly fabricated copper.

The end result of RAM Construction Service’s careful planning is a safe work site and a beautiful new east cornice for the Book Building. Detroit-based Ross Structural Steel installed new support steel for the cornice, corbels and parapet wall. The cornice, corbels and caryatids were replicated in fiberglass, lightening the entire assembly, and reducing the weight of each “maiden” from 2,400 lbs. to 400 lbs. Fiberglass is used in lieu of terra-cotta, because of “the weight, the cost and the long production time for terra-cotta,” said Mazur. “If we had done this job in terra-cotta and had been doing it right now, the terra-cotta would have had to have been ordered two years ago.”

Using the fiberglass cornice as a substructure, CASS Sheet Metal, Detroit, replaced the cornice’s deteriorated copper section with newly fabricated copper. Another

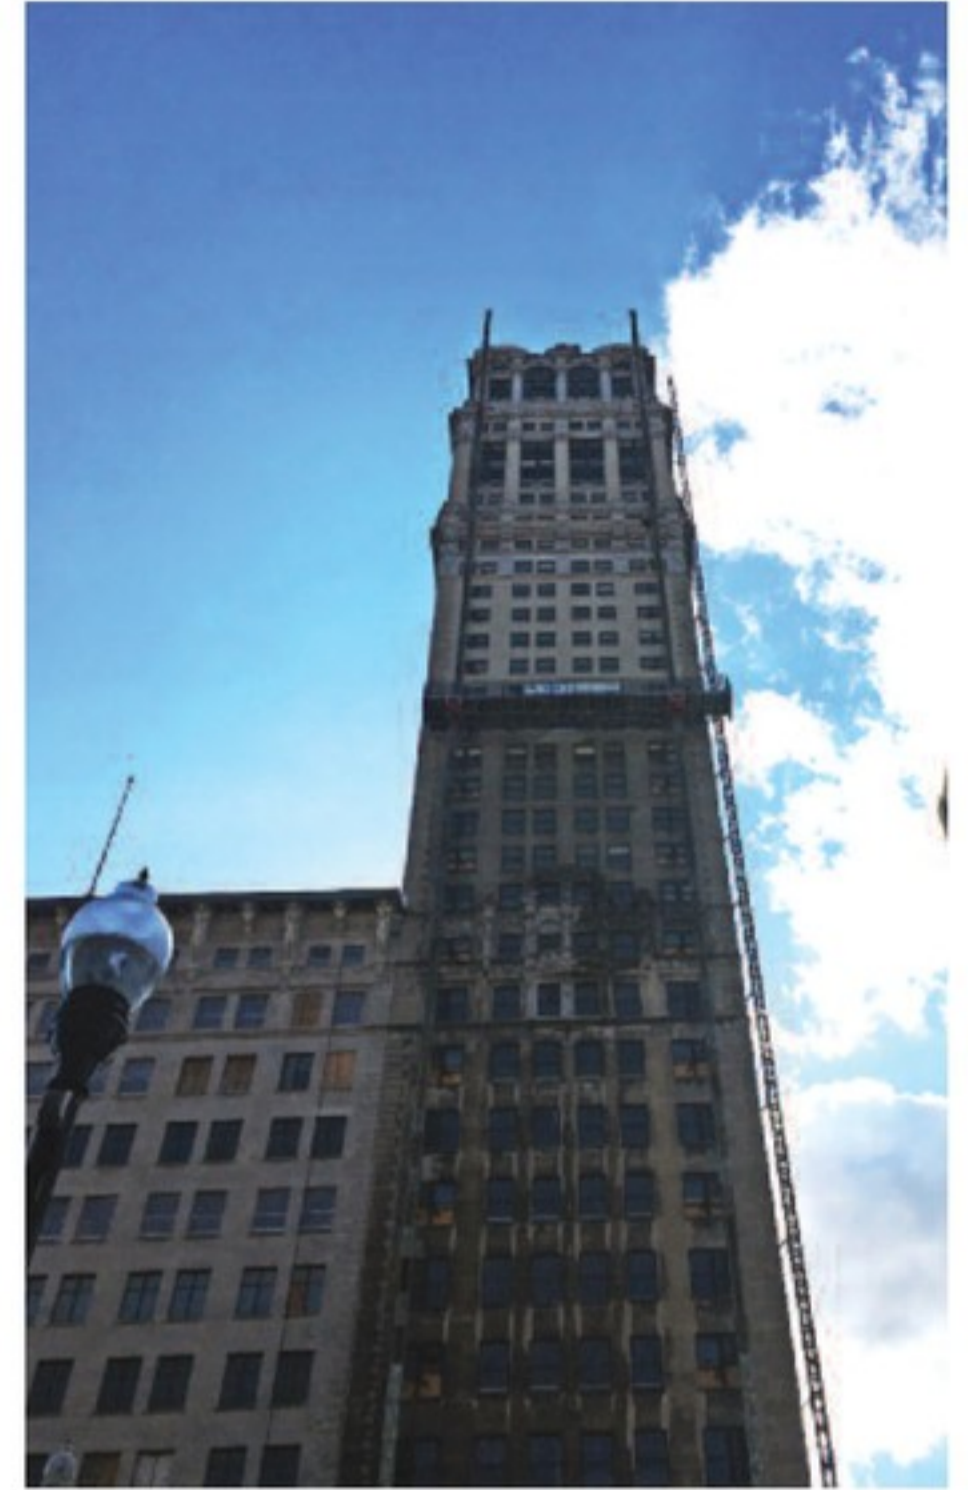
**Right:** RAM Construction Services is using the chemical-free JOS System to clean the Book Buildings.

Of course, it isn't smoke. RAM Construction Services is using the chemical-free JOS System originally invented in Germany to clean the Book Buildings. "Basically, the JOS System blasts the stone and brick with fine glass beads," said Mazur. "It doesn't damage the stone or other surface materials at all. We did a large portion of the Detroit Institute of Arts with it, as well as a large project in downtown Toledo called the Berdan."

The JOS System is apropos for the Motor City. The system actually recycles and uses pulverized automotive windshields. "It is a low-pressure 30 psi system used in conjunction with water to keep the dust down," said Mazur. "A person could place their hand in front of the spray and not even be impacted."

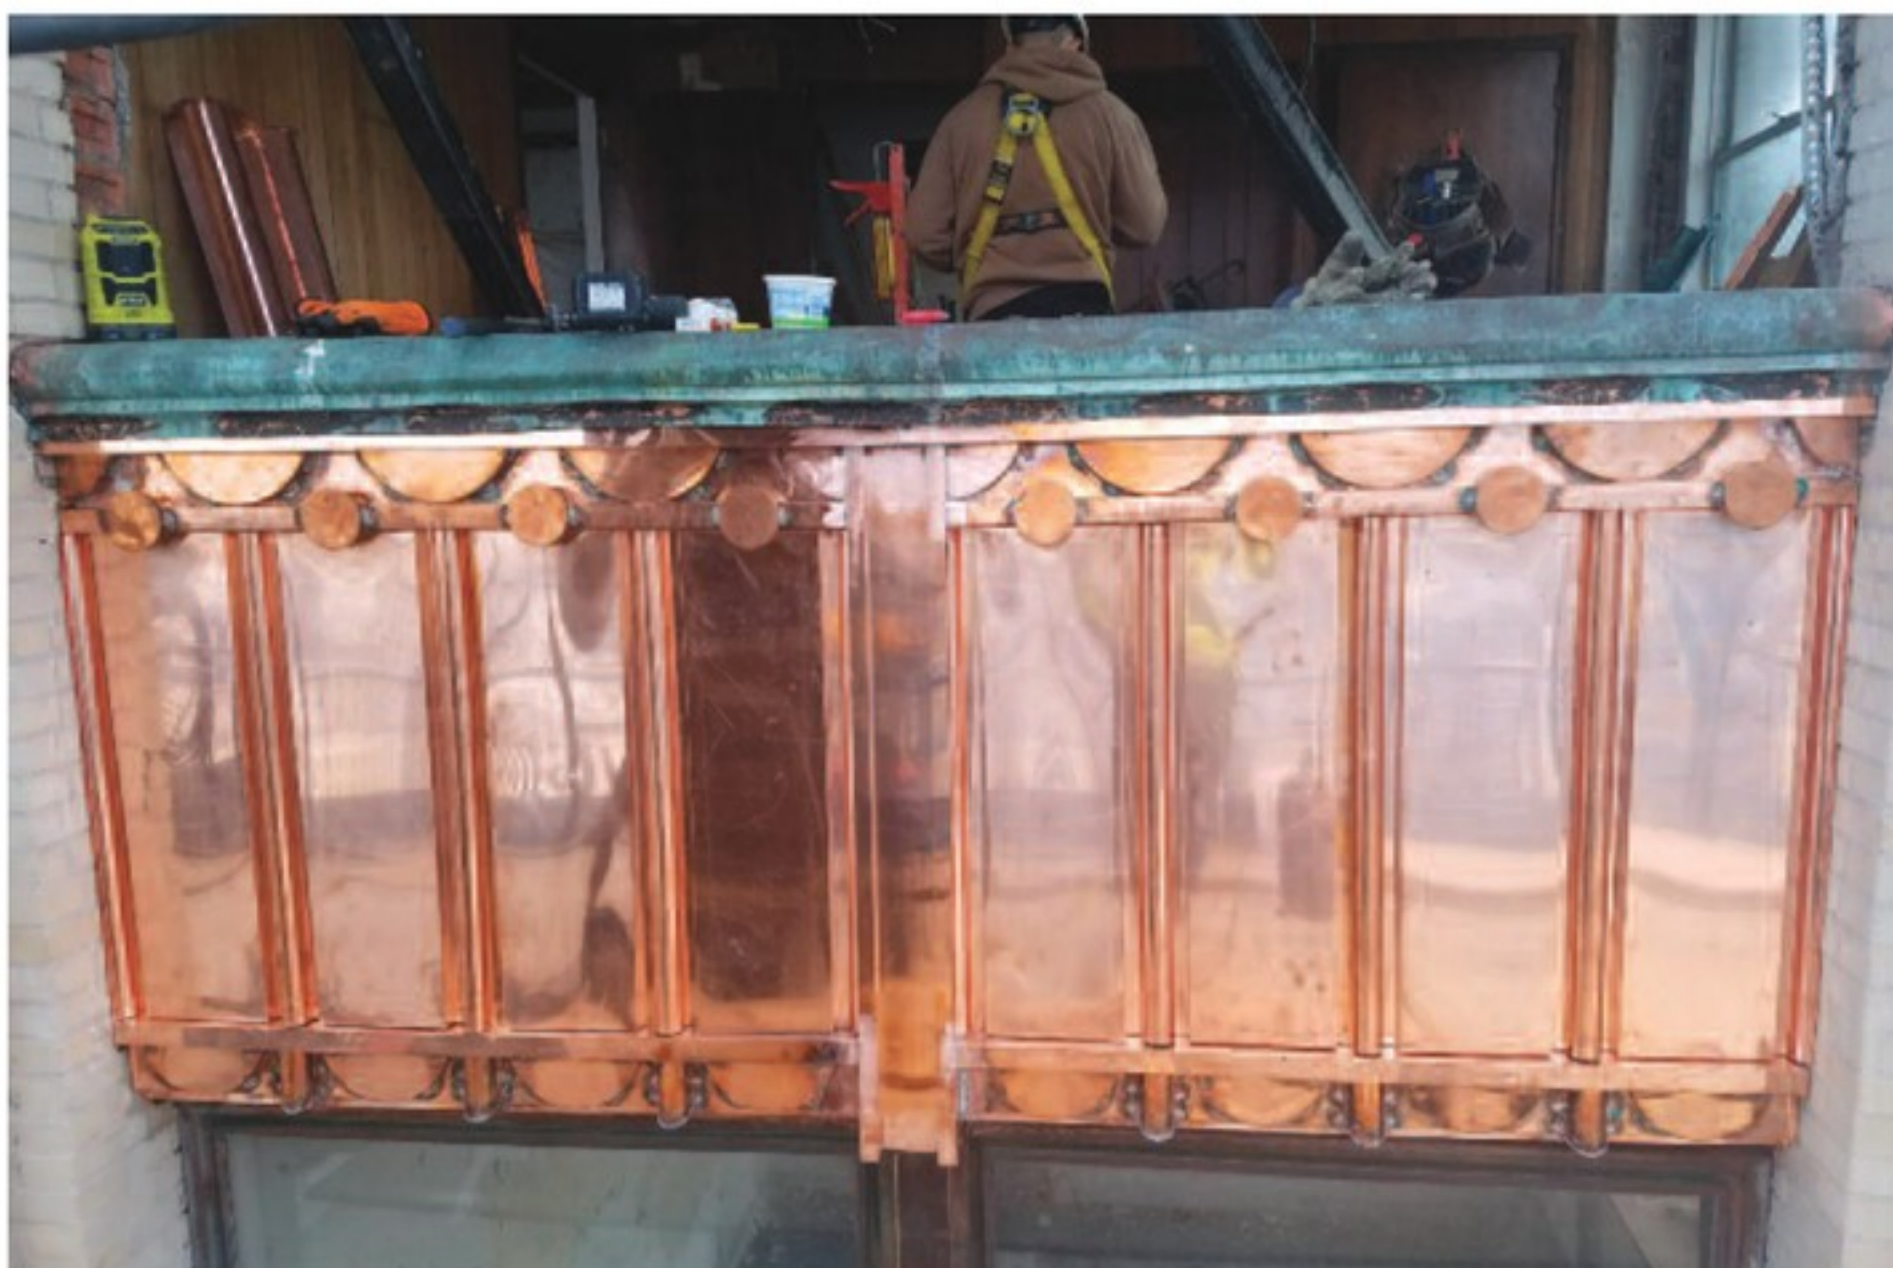
CASS Sheet Metal replaced, but mainly repaired, the ornate, copper spandrel panels located on three different floors of the Book Tower. Shown above, one of the newly replicated spandrel panels is aglow in new copper. Ultimately, CASS sprayed a patina accelerator on the newly fabricated copper to blend it with the seasoned, greenish-blue color of the existing spandrels.

CASS's craftsmanship is bringing the exterior walls back to life as well, both in form and function. The CASS Sheet Metal crew replaced, but mainly repaired, the ornate, copper spandrel panels located on three different floors, each floor having a slightly different design.

CASS replaced 10 missing spandrel panels, some of which had been lost in the severe windstorm of March 2017. "The new panels are all hand-built and custom-fabricated in our shop," said Parvin. "We did it the way it was done in the 1920s. Everything on the job is from flat stock, and every new copper piece was custom-built in our shop to match historical requirements."

In the spirit of restoration, however, the majority of the spandrel panels were repaired. "Since the 1920s various screws and wires had been driven into the panels to keep it in place," said Parvin, "and these holes, like the ones in the roof panels, had been filled with asphalt patches. In some cases, the holes were leading to a split in the

metal. We used copper patches to repair the panels, making sure we fixed any splits and secured the panels to the building."
